TECHNICAL REPORT CERC-85-8

BREAKWATER REHABILITATION STUDY, CRESCENT CITY HARBOR, CALIFORNIA

Coastal Model Investigation

Coastal Engineering Research Center

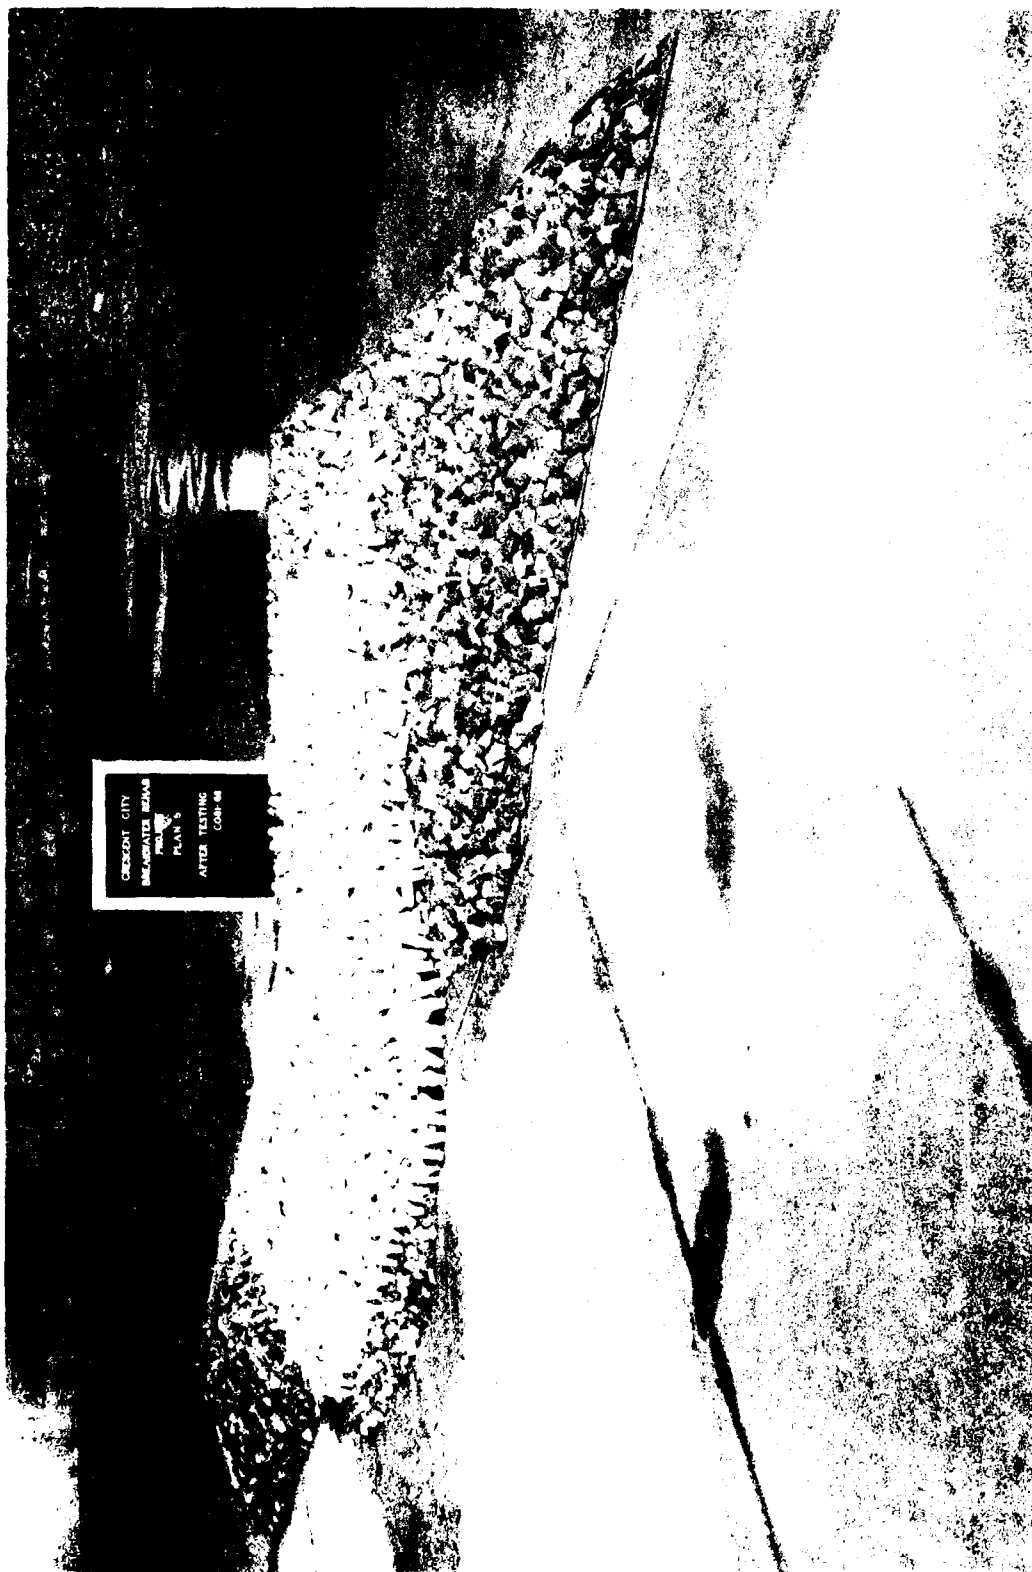
Photo 55. Seaward oblique view of Plan 5 after completion of abbreviated hydrograph

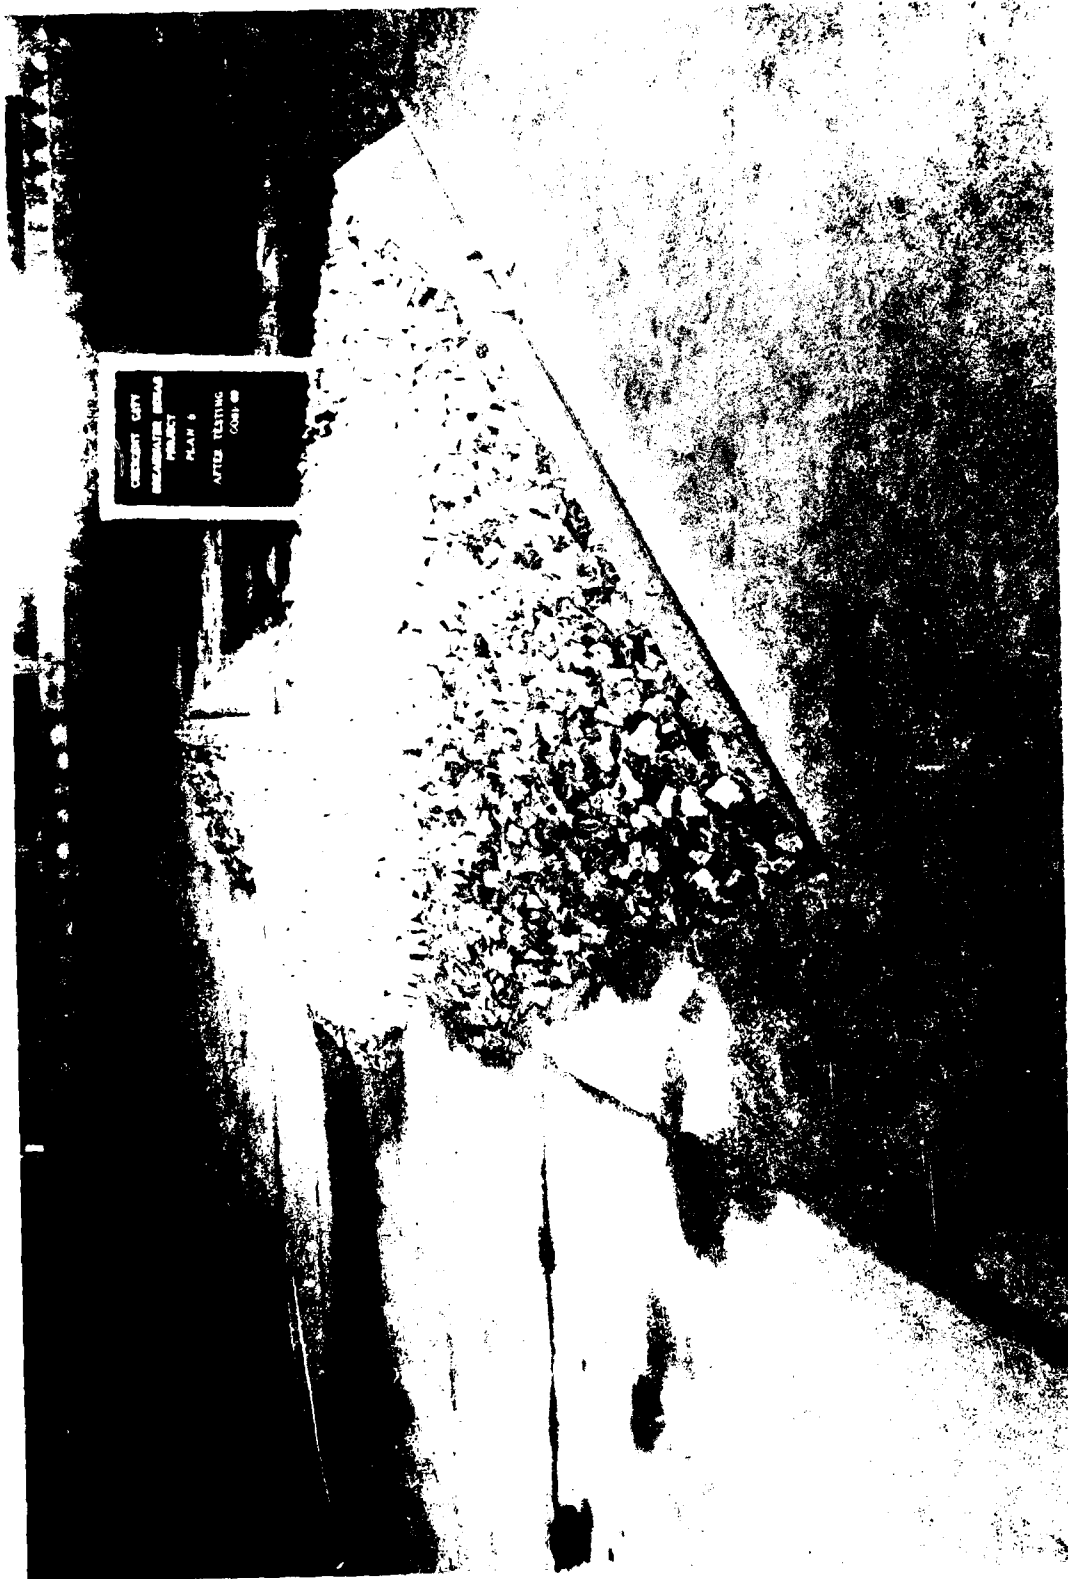
Photo 56. Seaward end view of Plan 5 after completion of abbreviated hydrograph

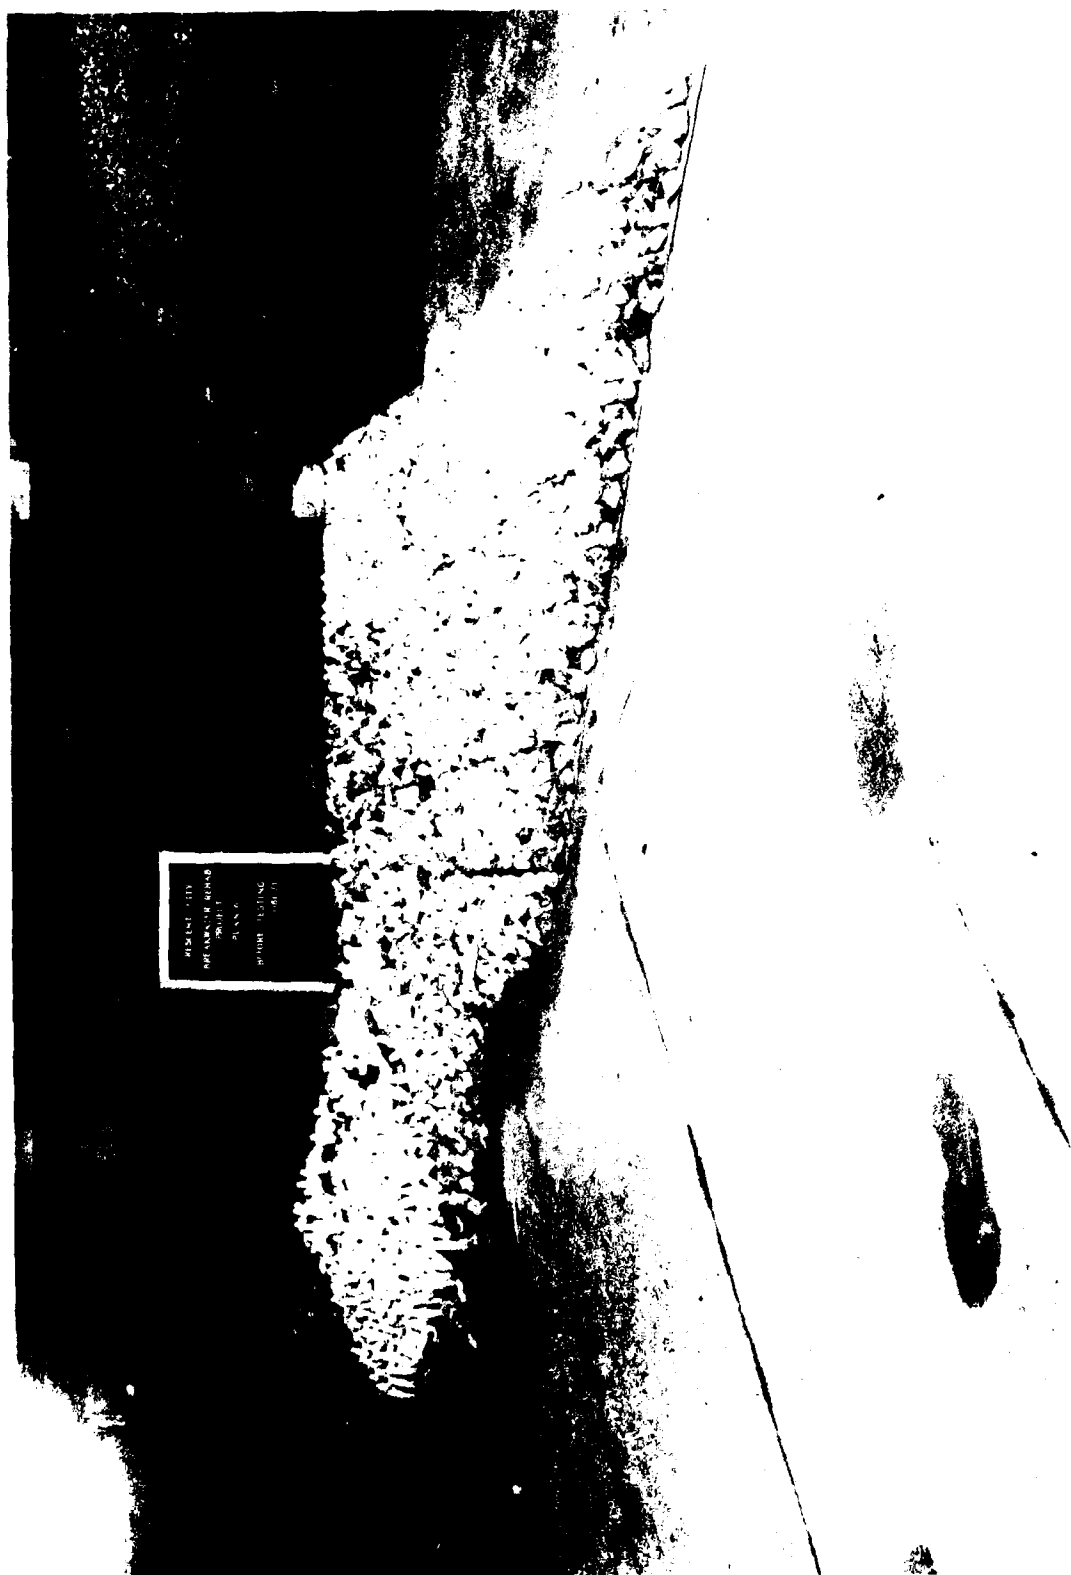
Photo 58. Seaward oblique view of Plan 6 before wave attack

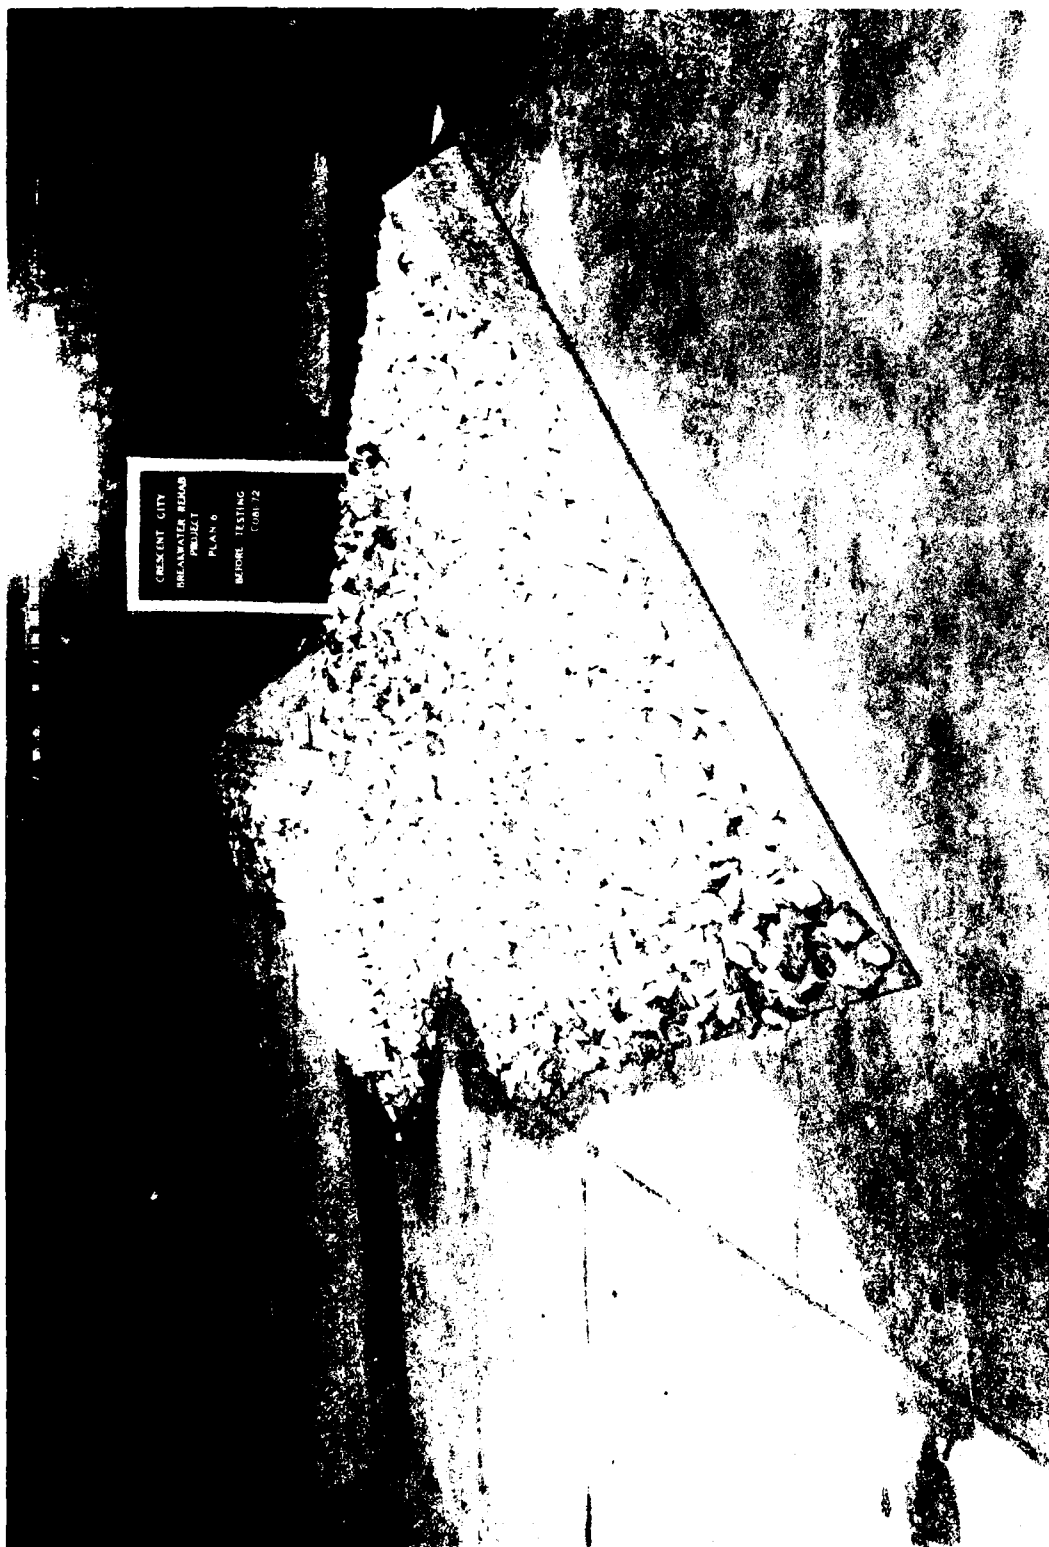
Photo 59. Seaward end view of Plan 6 before wave attack

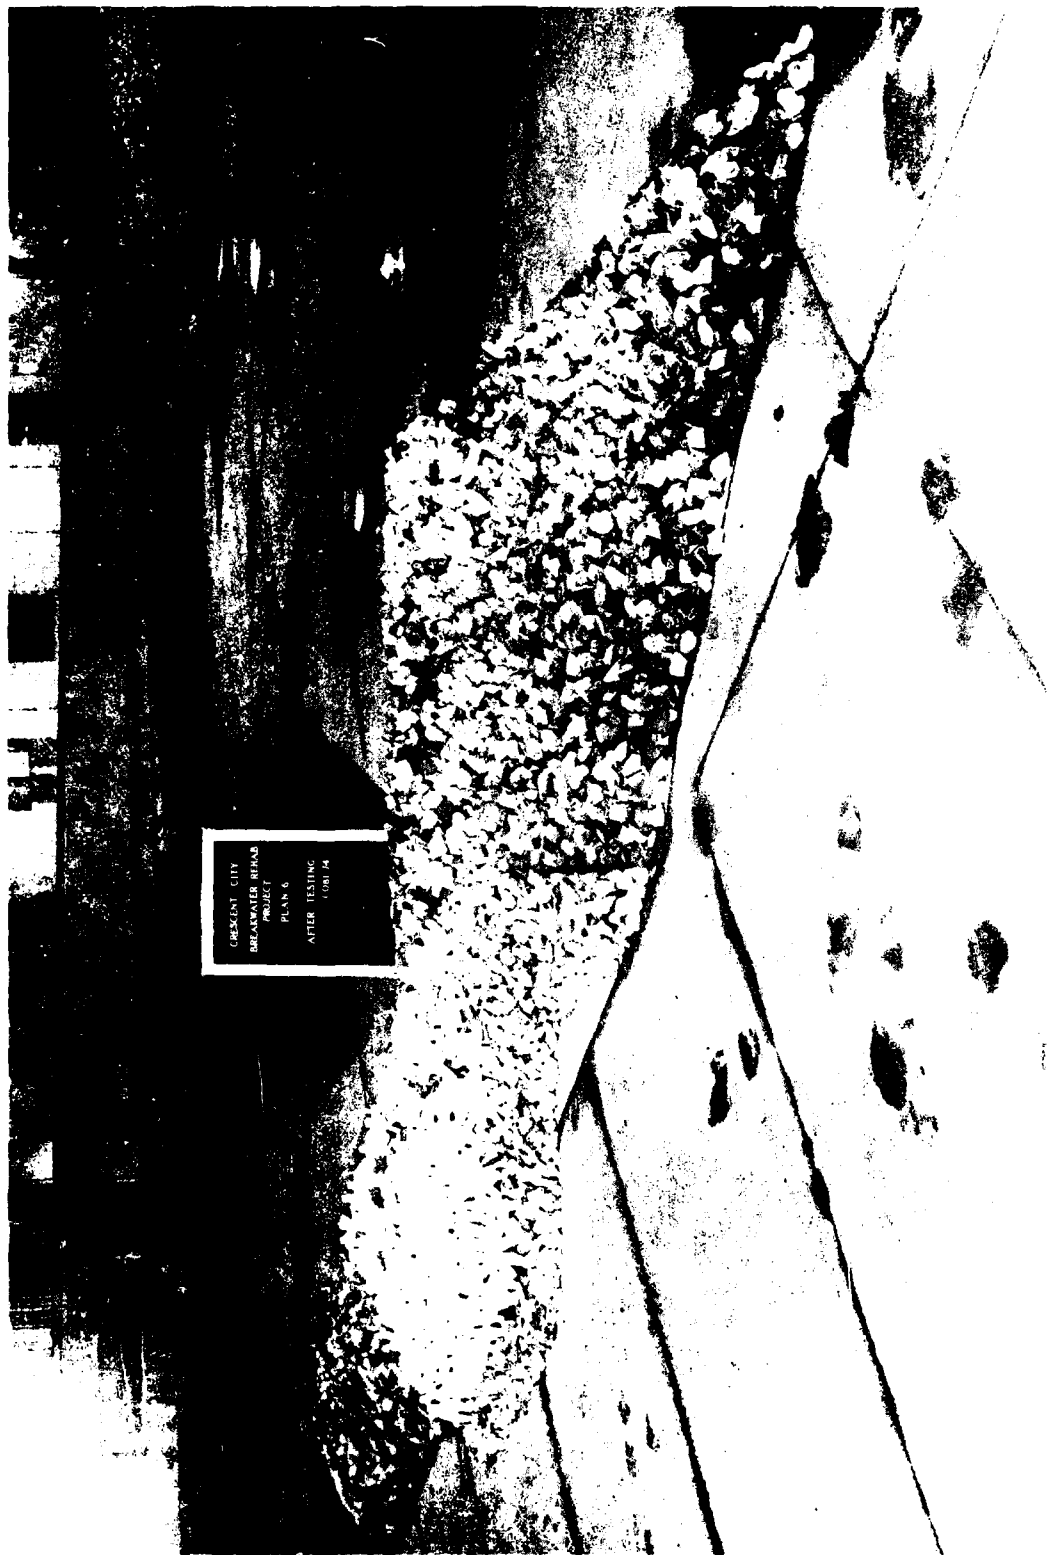
Photo 61. Seaward oblique view of Plan 6 after completion of abbreviated hydrograph

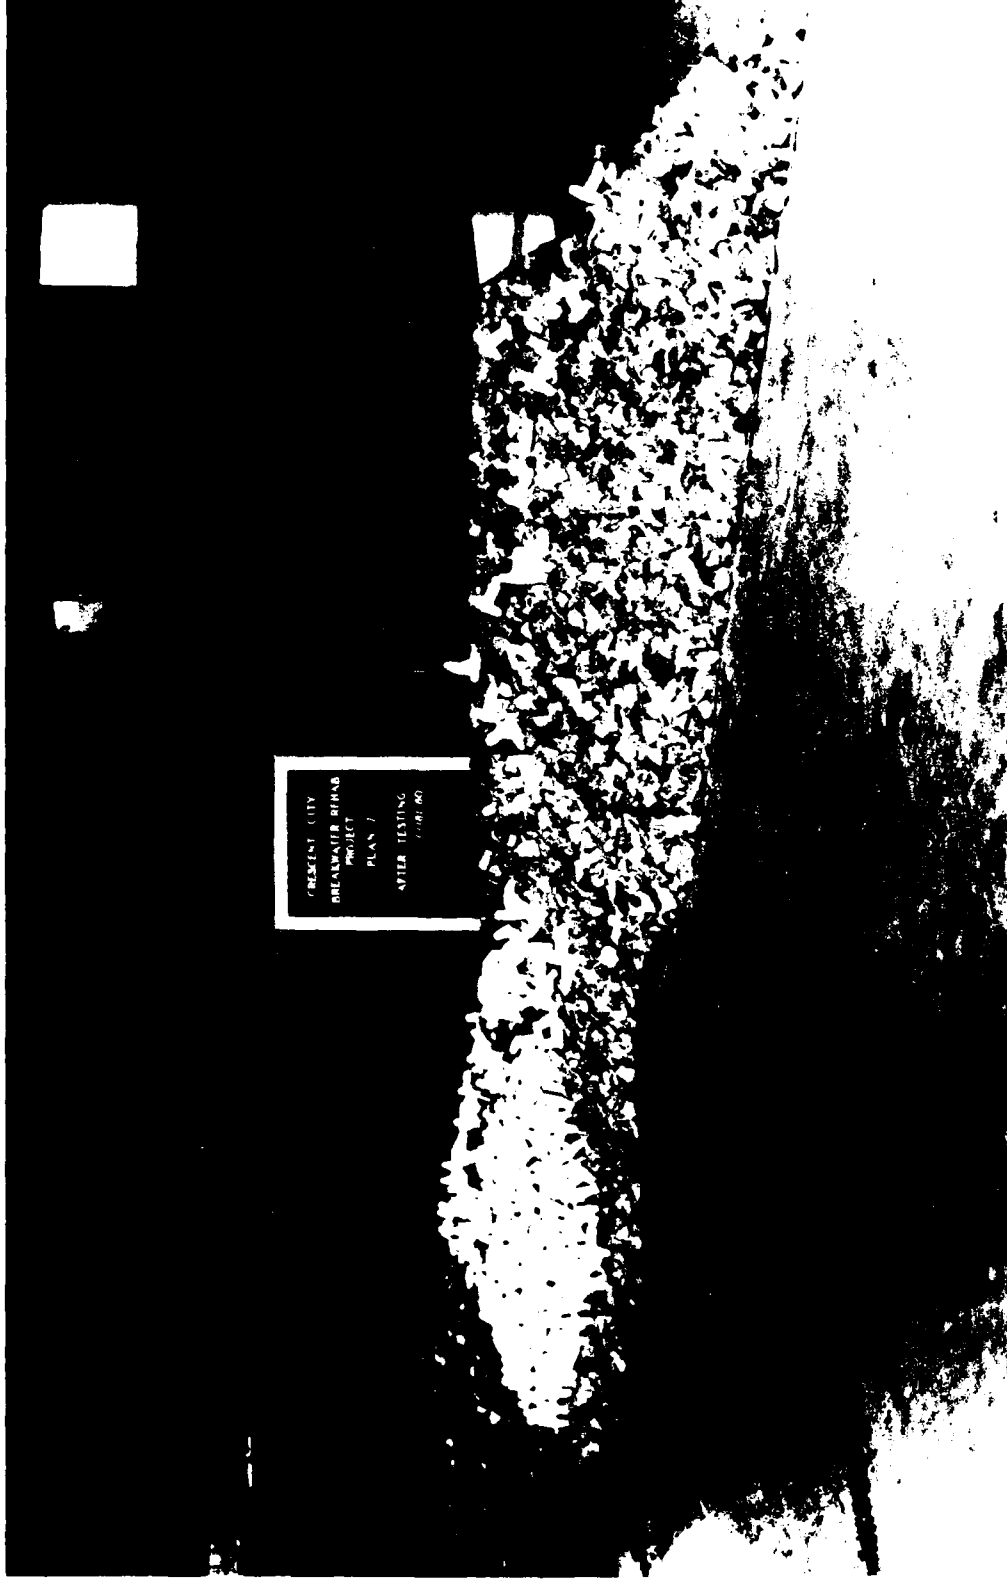
Photo 67. Seaward oblique view of Plan 7 after completion of abbreviated hydrograph

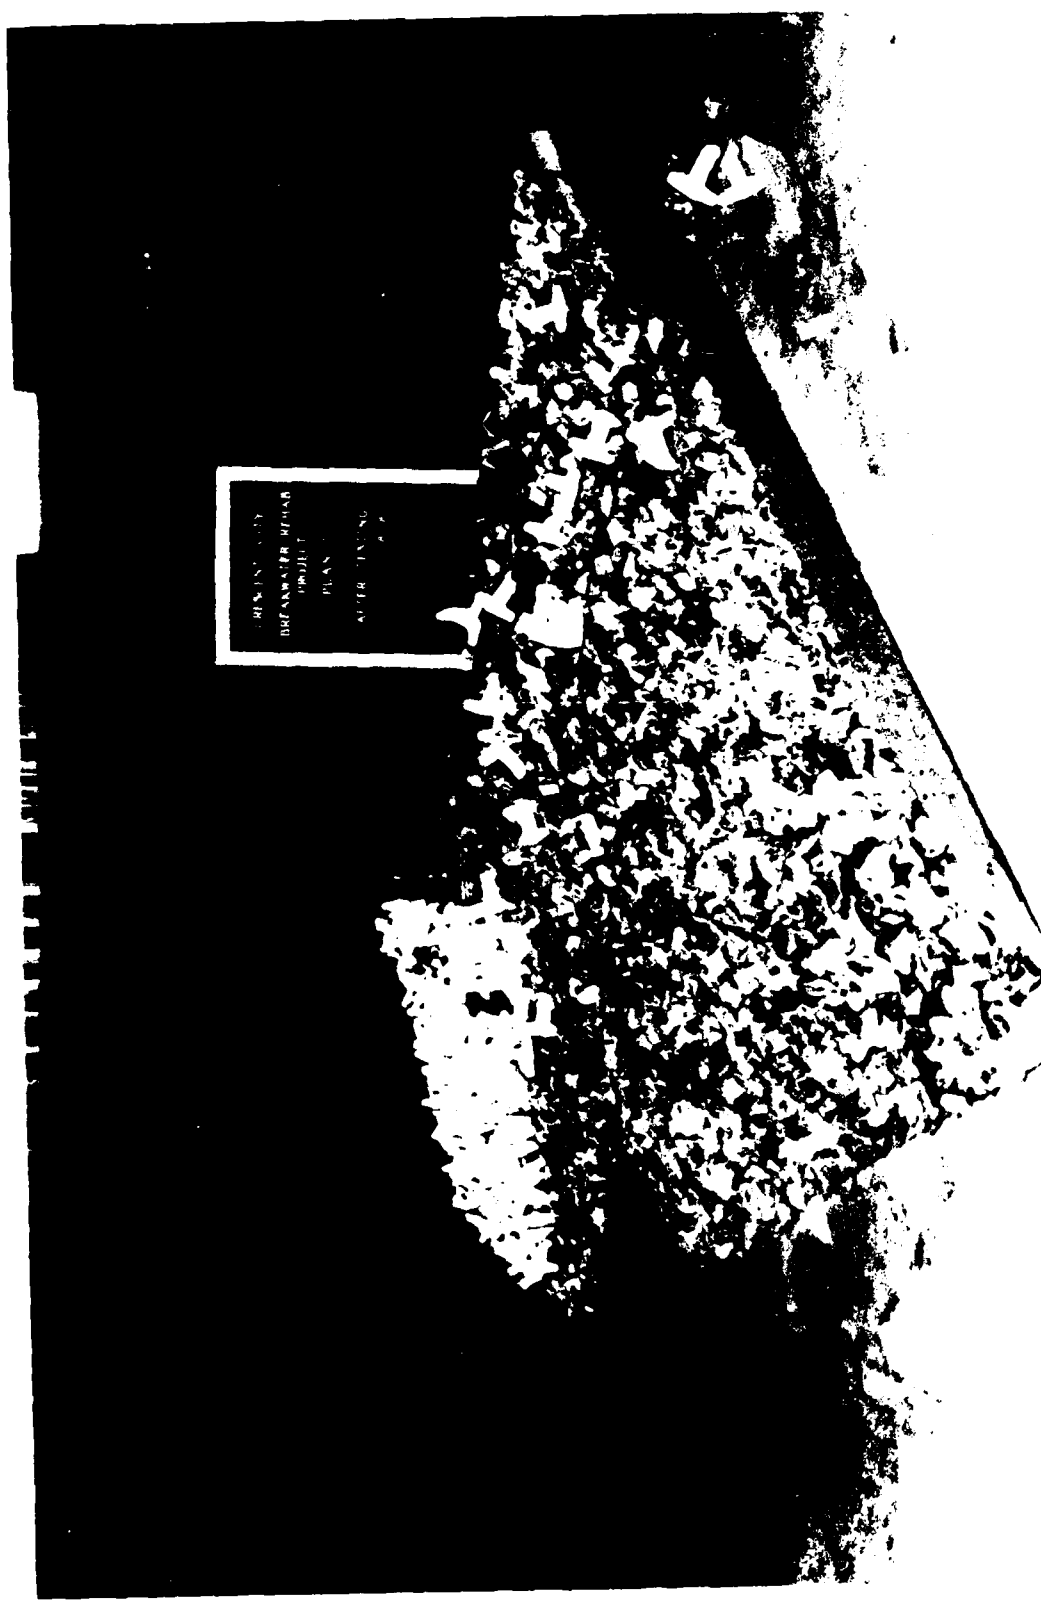
Photo 68. Seaward end view of Plan 7 after completion of abbreviated hydrograph

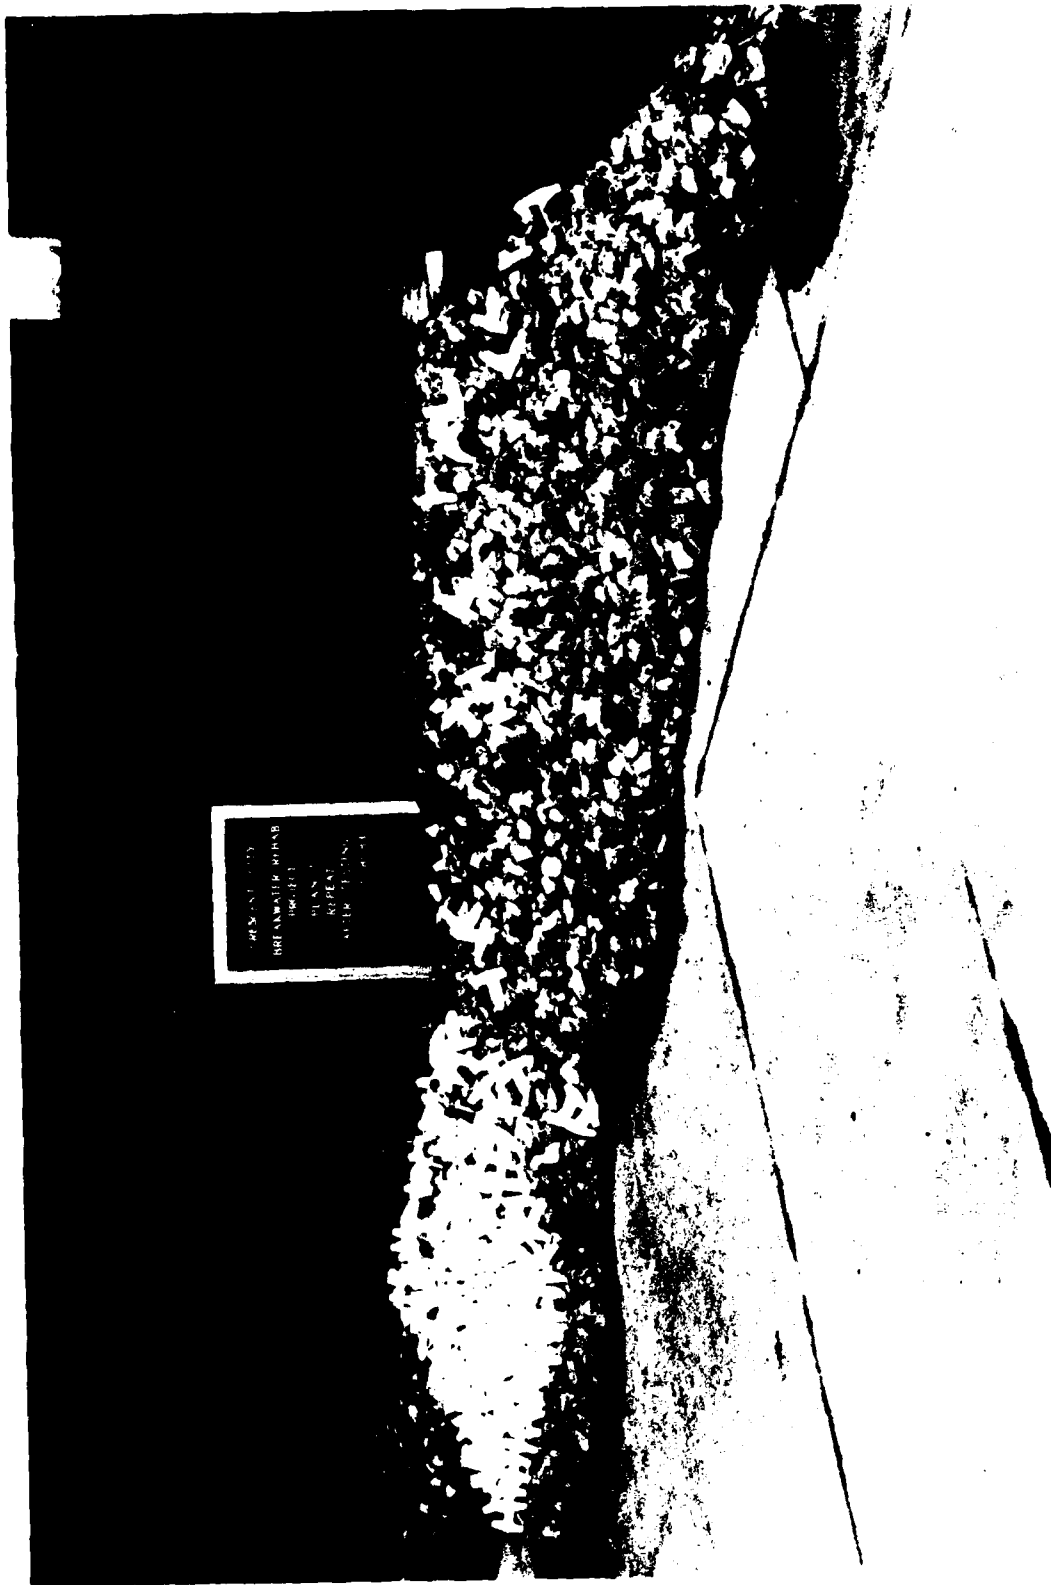
Photo 70. Seaward oblique view of Plan 7 repeat after completion of abbreviated hydrograph

more random fashion. The units along the seaward transition sustained considerable damage for the repeat test. Photos 96-98 show the structure after repeat testing. The repeat test indicated that toe placement is critical in the stability of the structure.

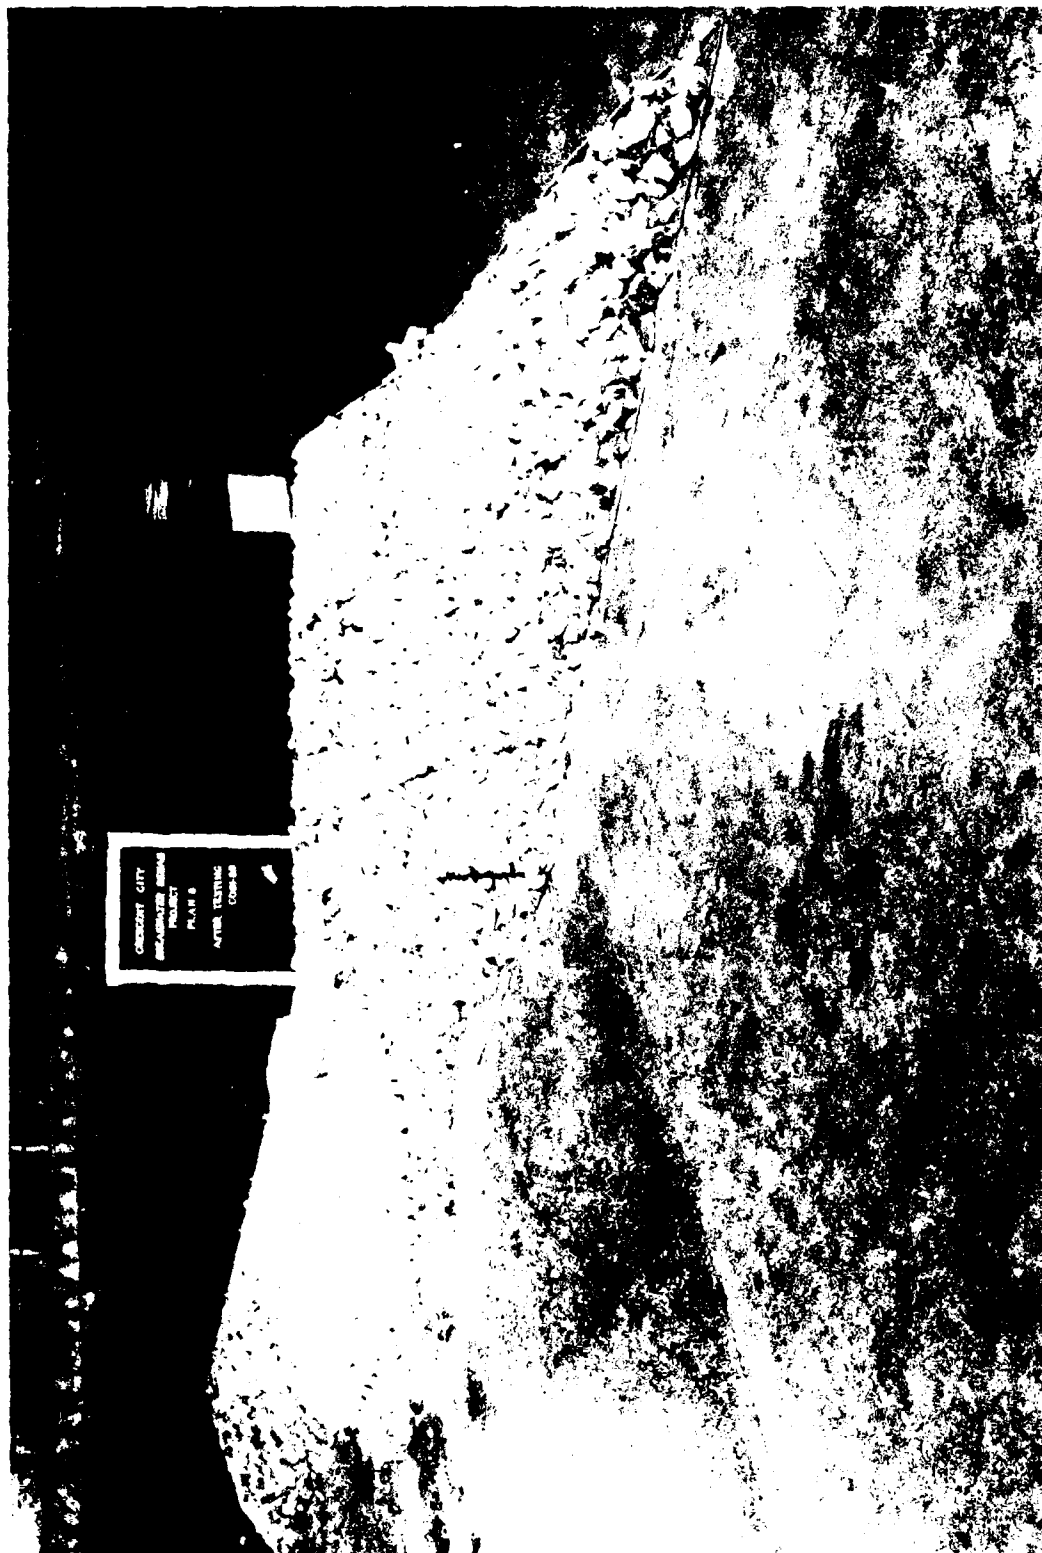
Photo 76. Seaward oblique view of Plan 8 after completion of abbreviated hydrograph.

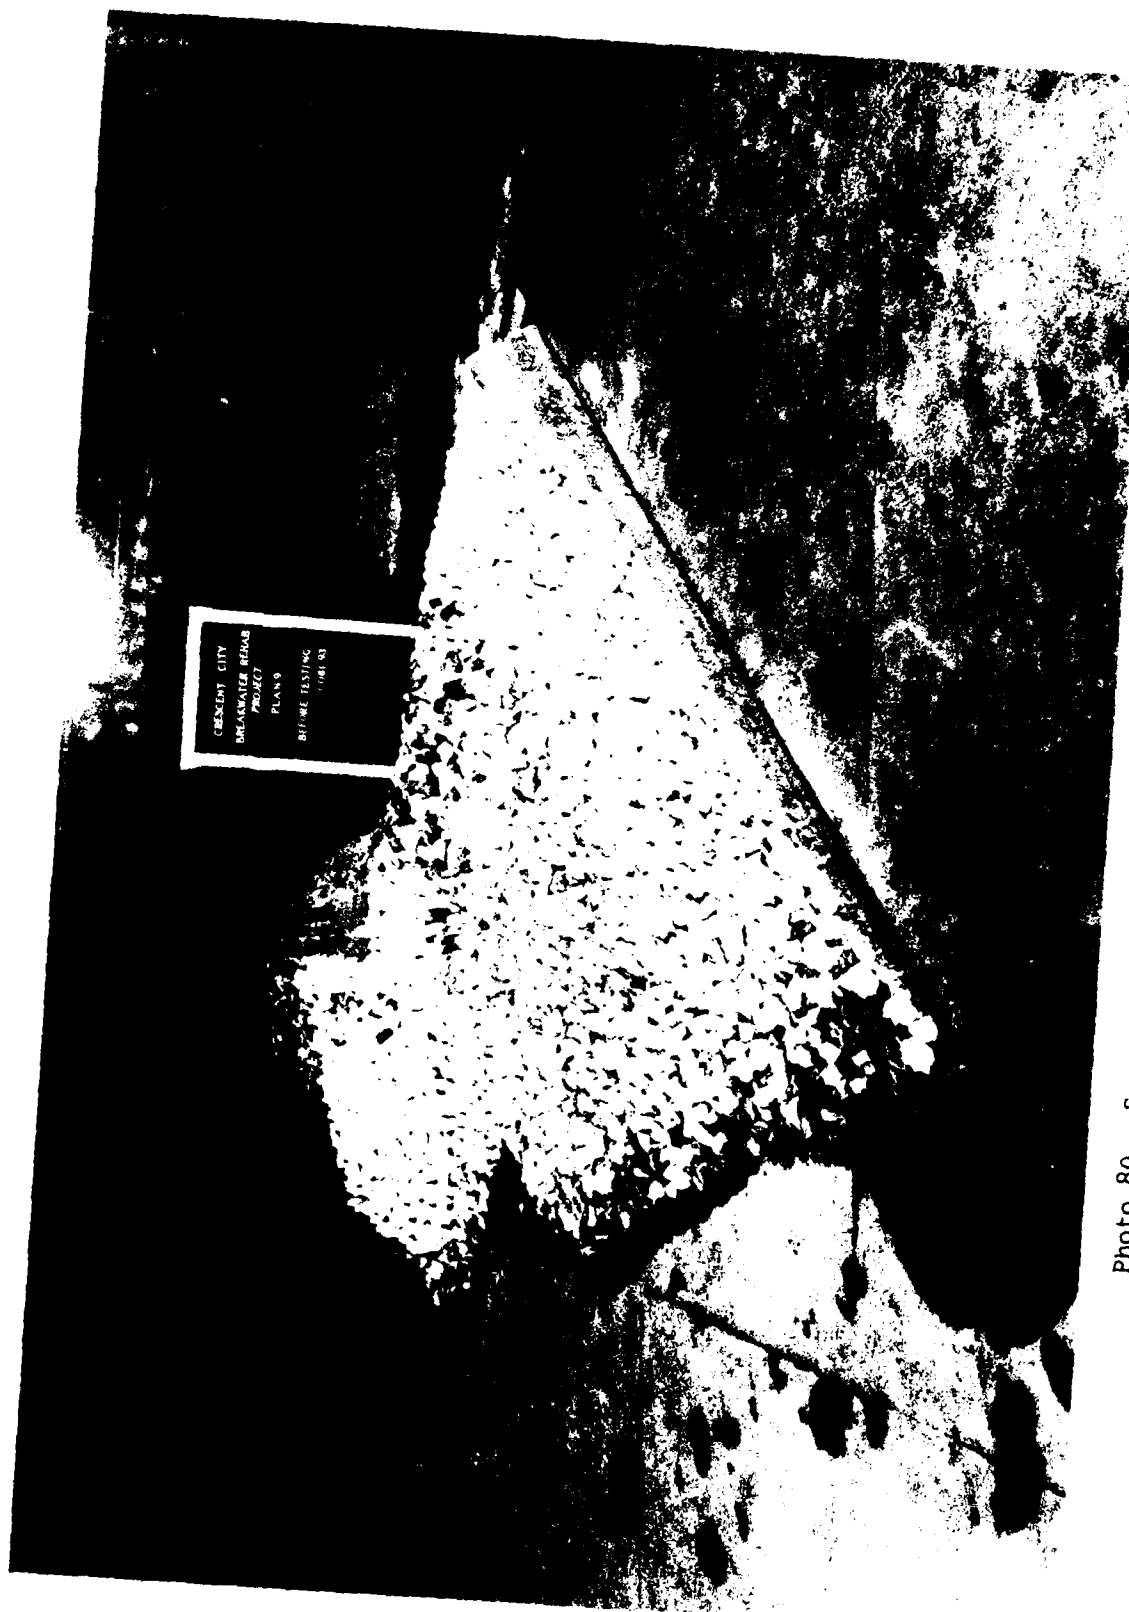
Photo 80. Seaward end view of Plan 9 before wave attack

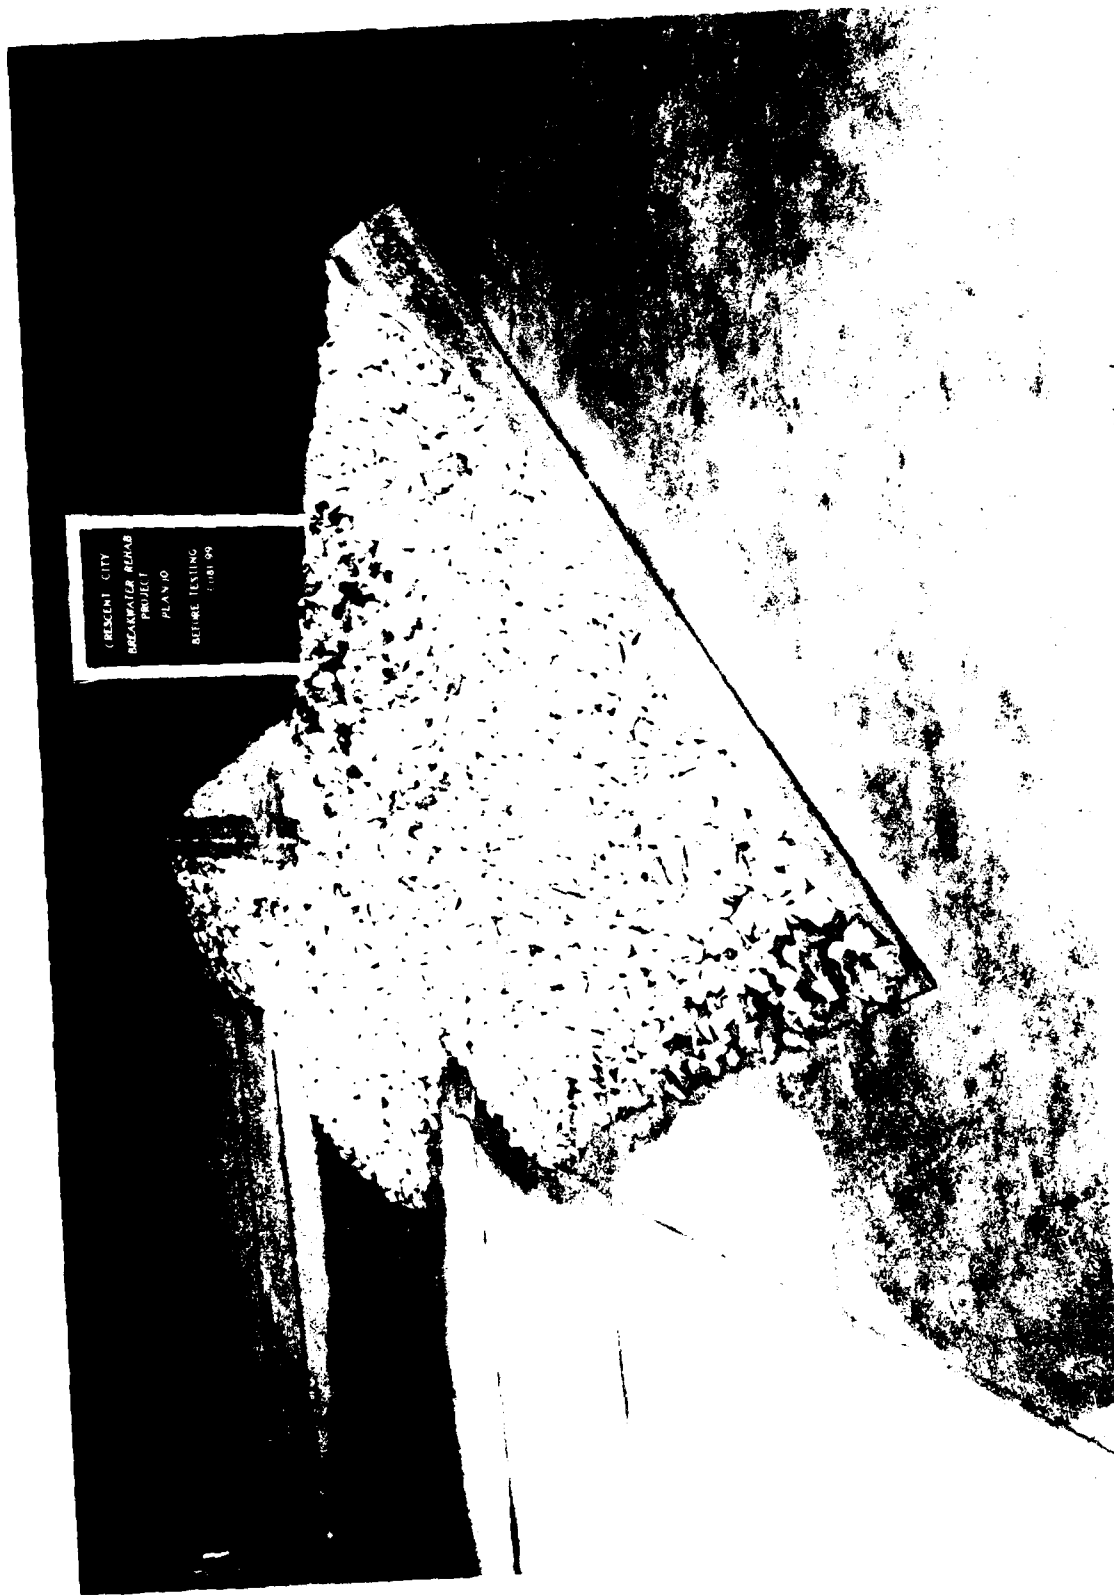
Photo 86. Seaward end view of Plan 10 before wave attack

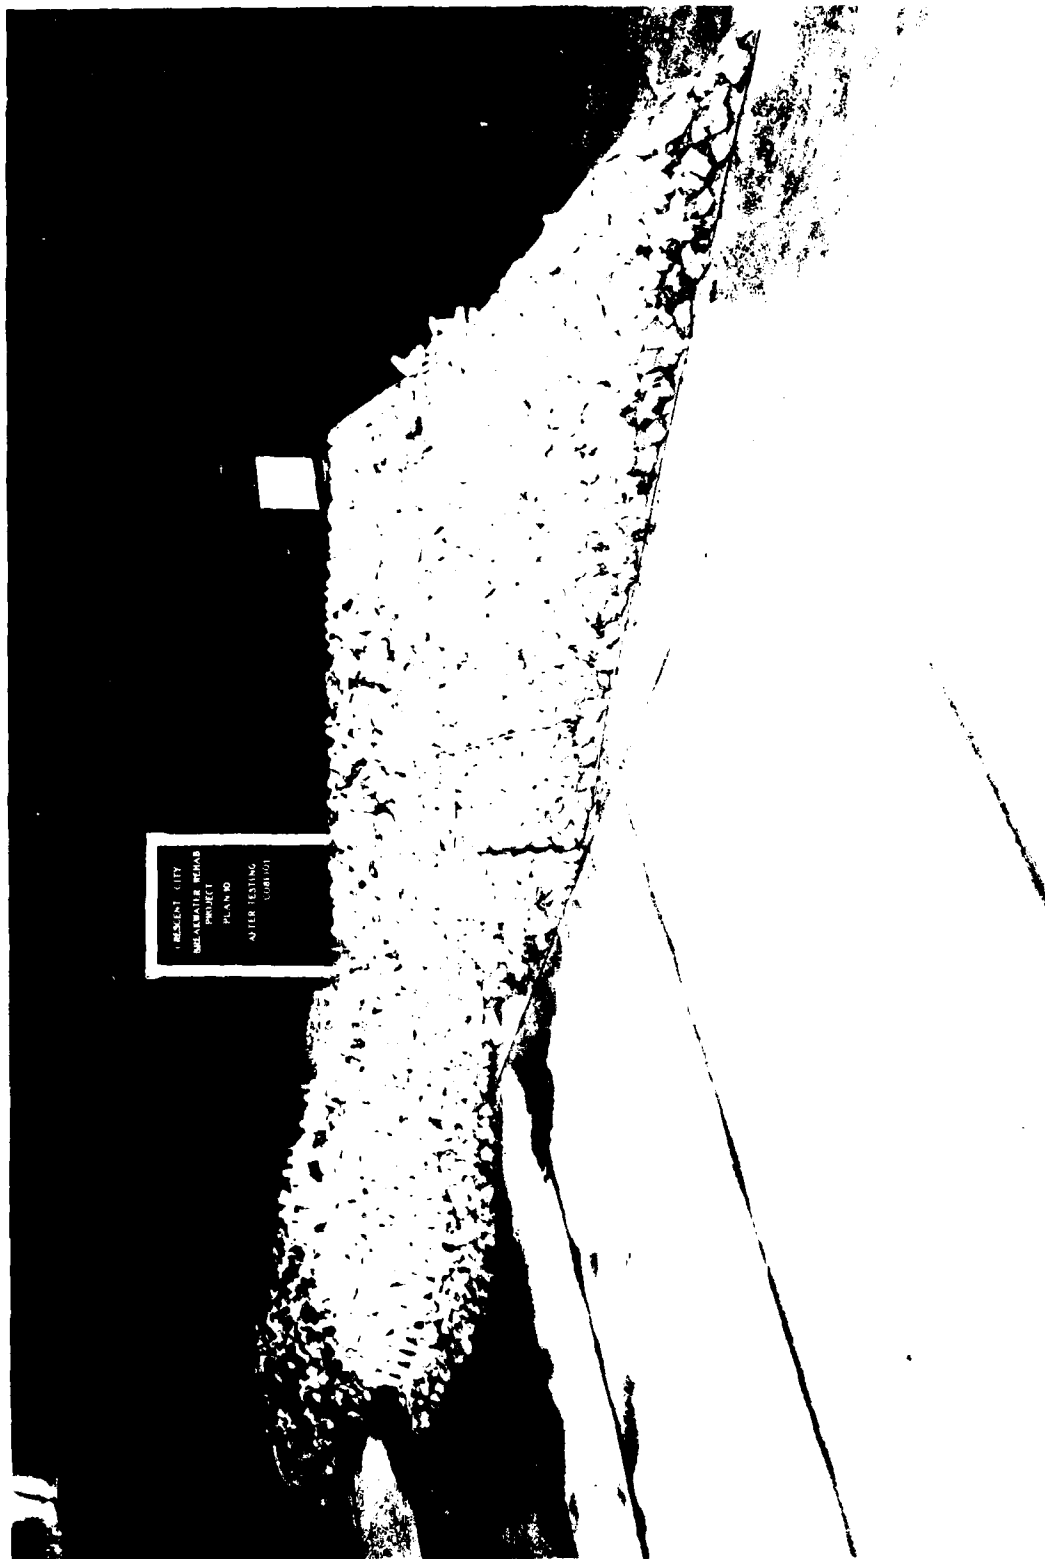
Photo 88. Seaward oblique view of Plan 10 after completion of abbreviated hydrograph

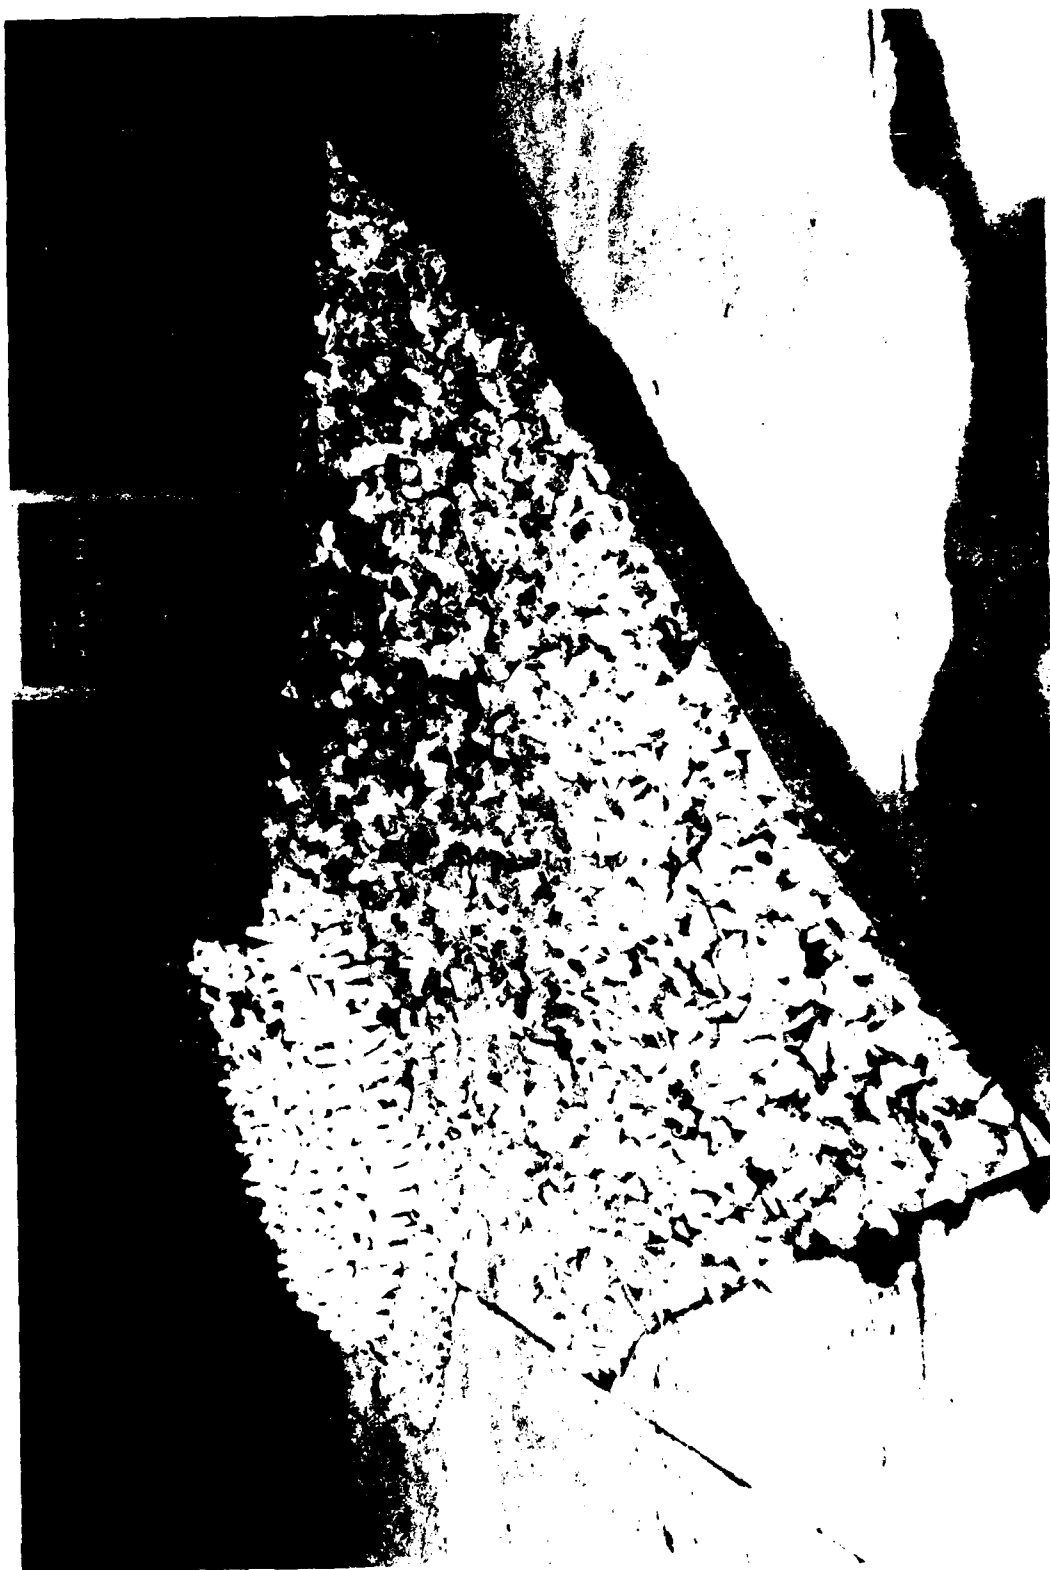
Photo 92. Seaward end view of Plan 11 before wave attack
